# College Street Revitalization Plan: Brownfield Inventory Report

August 14, 2026

# Project Overview

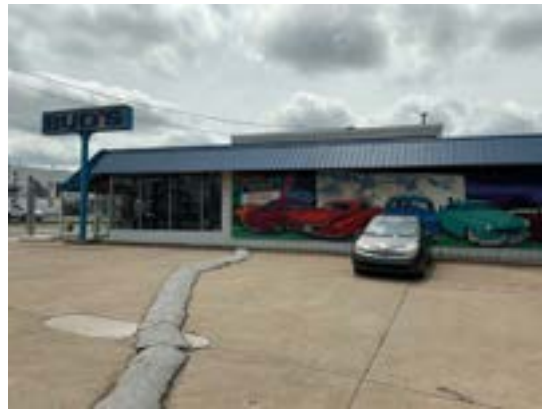
| <b>Primary Follow-Up Category:</b> Strategic Redevelopment / Environmental Due Diligence Candidate | | |
| <b>Key Notes:</b> High-visibility corner property with strong corridor exposure, active use indicators, multiple access points, and high site readiness. The property also included environmental due diligence indicators, including flammable materials signage and confirmed or likely UST/LUST and suspected hazardous storage flags. Future review should focus on confirming environmental records, understanding current site operations, and evaluating long-term redevelopment or reinvestment potential. | | |

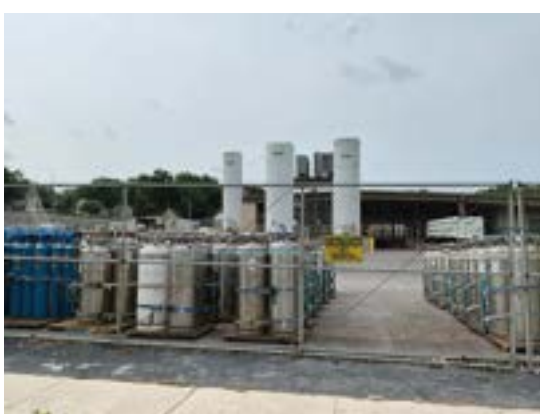
| Address | 1405 W Walnut St | |

**Primary Follow-Up Category:** Environmental Due Diligence Candidate

**Key Notes:** Industrial/storage-oriented property located in a floodway with high Environmental Concern and high Redevelopment/Readiness scores. Observed indicators included outdoor drums/containers, outdoor chemical storage, heavy equipment storage, industrial process equipment, hazardous materials signage, flammable materials signage, and environmental warning signage. The site appears appropriate for future environmental due diligence and coordination related to industrial operations, floodplain constraints, and adjacent opportunity areas.

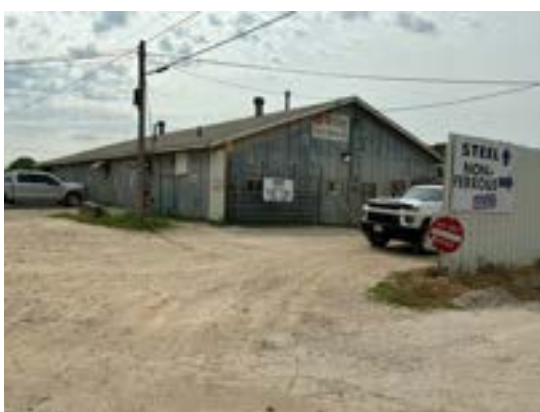
| Address | 1330 W Water St | |

**Primary Follow-Up Category:** Environmental Due Diligence Candidate

**Key Notes:** Industrial property associated with material storage and active operations. High Environmental Concern was driven by indicators including chemical odors, outdoor chemical storage, heavy equipment storage, fill material, industrial process equipment, and suspected hazardous storage/active industrial chemical use flags. The property also scored high for site readiness, suggesting that future assessment or planning coordination may be feasible if owner interest and environmental due diligence align.

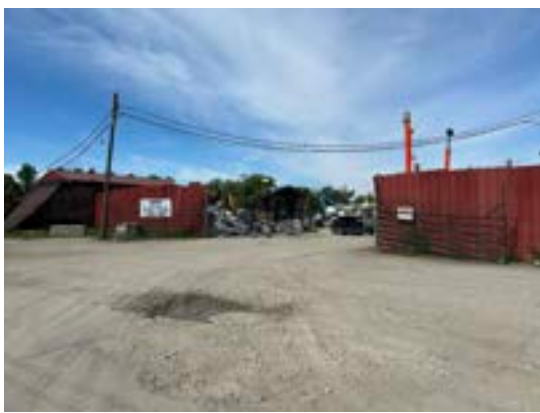
| Primary Follow-Up Category: Environmental Due Diligence Candidate | | |
| <b>Key Notes:</b> Active heavy-industrial property with high Environmental Concern and high physical distress scores. Observed indicators included chemical odors, outdoor drums/containers, outdoor chemical storage, heavy equipment storage, fill material, distressed vegetation, industrial process equipment, open storage, loose debris/materials, and abandoned vehicles. The site may warrant future environmental due diligence and site condition review prior to any redevelopment or reinvestment planning. | | |

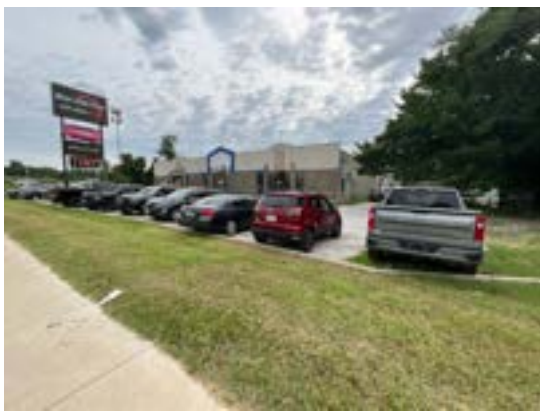
| Primary Follow-Up Category: Strategic Redevelopment / Environmental Due Diligence Candidate | | |
| <b>Key Notes:</b> Highly visible property near Kansas Expressway with strong Redevelopment Opportunity and Site Readiness scores. The property is associated with a closed UST record and critical environmental flags including confirmed or likely UST/LUST, suspected hazardous storage, and active industrial chemical use. Future review should focus on confirming environmental records, understanding current site uses, and evaluating long-term redevelopment potential given the site's visibility and access characteristics. | | |

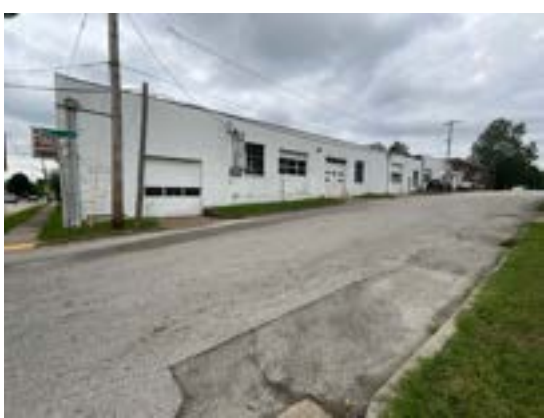
| Address | 208 S New Ave | |

**Primary Follow-Up Category:** Strategic Redevelopment Opportunity

**Key Notes:** High-opportunity property with strong visibility, access, and adjacent redevelopment indicators. The site scored high for Environmental Concern, Redevelopment Opportunity, and Site Readiness, with elevated Physical Distress. Environmental Concern was driven by distressed vegetation and suspected hazardous storage, while Redevelopment Opportunity was supported by corner/corridor visibility, adjacent opportunity sites, and public realm context. Future review should consider both environmental due diligence and redevelopment feasibility.

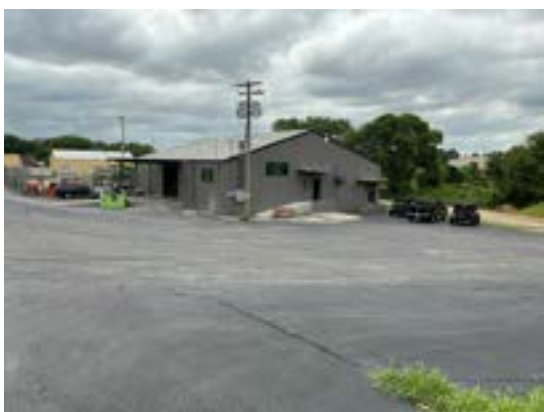
| Address | 803 W Olive St | |

**Primary Follow-Up Category:** Environmental Due Diligence / Reinvestment Opportunity

**Key Notes:** Active industrial/materials-related property with high Environmental Concern, high Redevelopment Opportunity, and high Site Readiness. Observed indicators included outdoor drums/containers, heavy equipment storage, flammable materials signage, open storage, and strong adjacent opportunity indicators. The site may be appropriate for future environmental due diligence and owner coordination related to reinvestment or long-term site planning.

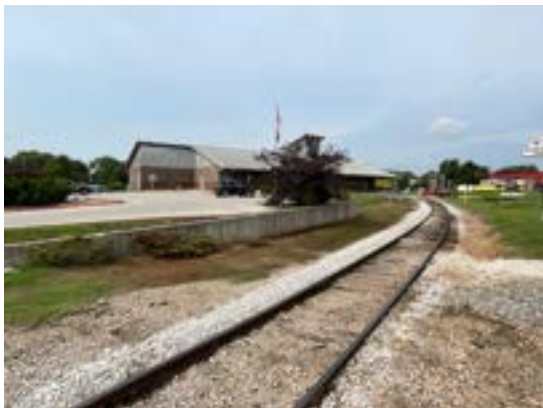
| Primary Follow-Up Category: Environmental Due Diligence / Reinvestment Opportunity | | |
| Key Notes: Highly visible property near a major intersection and commercial corridor with high Environmental Concern, Redevelopment Opportunity, and Site Readiness scores. The property included vent pipe/tank indicators and a confirmed or likely UST/LUST flag. Because the site is in a high-visibility corridor location and has strong access/readiness characteristics, future review should evaluate environmental records and potential reinvestment or redevelopment opportunities. | | |

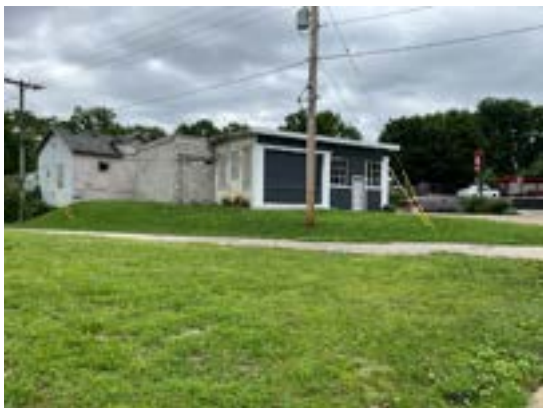
| Primary Follow-Up Category: Strategic Redevelopment / Environmental Due Diligence Candidate | | |
| Key Notes: High-opportunity corridor property with strong visibility, corner location, and major intersection proximity. The site scored high for Environmental Concern and Redevelopment Opportunity, with elevated Physical Distress and moderate readiness. Environmental Concern was driven by a confirmed or likely UST/LUST flag. Future review should focus on environmental records, ownership coordination, and redevelopment feasibility given the property's prominent corridor location. | | |

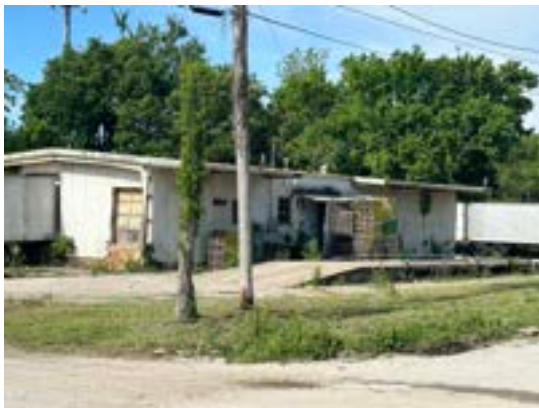
| Primary Follow-Up Category: Site Condition / Environmental Due Diligence Candidate | | |
| Key Notes: Industrial/storage-oriented property with high Environmental Concern and high Physical Distress. Observed indicators included stained soils/pavement, outdoor drums/containers, distressed vegetation, roof deterioration, exterior wall damage, foundation cracking, structural sagging, broken glass, open storage, loose debris/materials, and no active use observed. Future review should focus on site condition, environmental due diligence, and feasibility of stabilization, cleanup, or redevelopment planning. | | |

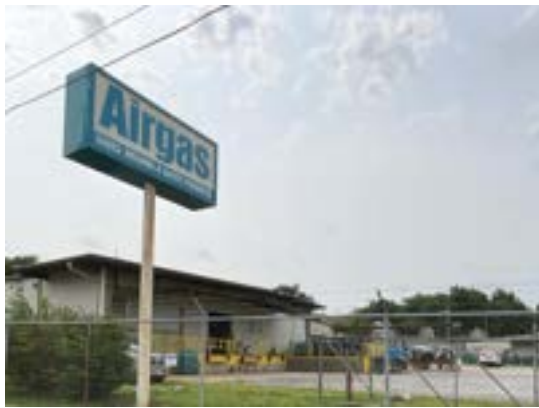
| Primary Follow-Up Category: Environmental Due Diligence Candidate | | |
| Key Notes: Industrial property with high Environmental Concern and high Site Readiness. Observed indicators included chemical odors, outdoor drums/containers, outdoor chemical storage, heavy equipment storage, industrial process equipment, hazardous materials signage, flammable materials signage, and environmental warning signage. Future review should focus on environmental due diligence, operational context, and coordination with surrounding industrial/redevelopment opportunities. | | |

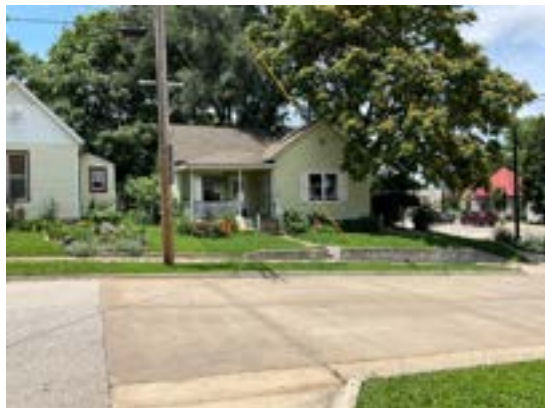
| Primary Follow-Up Category: Environmental Due Diligence / Corridor Opportunity | | |
| Key Notes: Corner property with high Environmental Concern, elevated Physical Distress, high Redevelopment Opportunity, and moderate readiness. Environmental concern was driven by outdoor drums/containers and confirmed or likely UST/LUST indicators. The property's corridor visibility and reuse potential make it appropriate for future due diligence and redevelopment feasibility review. | | |

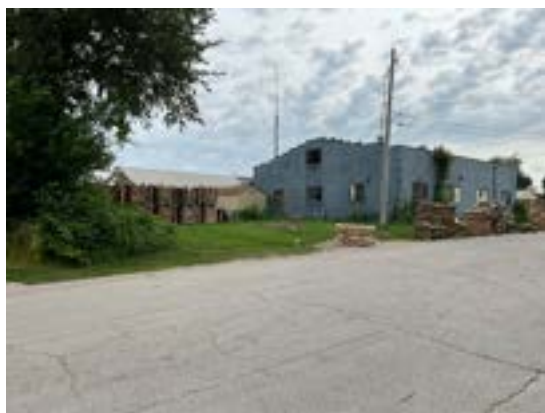
| Primary Follow-Up Category: Environmental Due Diligence / Site Condition Review | | |
| Key Notes: Industrial/storage-oriented property with high Environmental Concern and high Physical Distress. Indicators included outdoor drums/containers, heavy equipment storage, confirmed or likely UST/LUST, boarded openings, broken windows, exterior wall damage, open storage, loose debris/materials, abandoned vehicles, and overgrown access points. The site may warrant environmental due diligence and site condition review before any future redevelopment or reuse planning. | | |

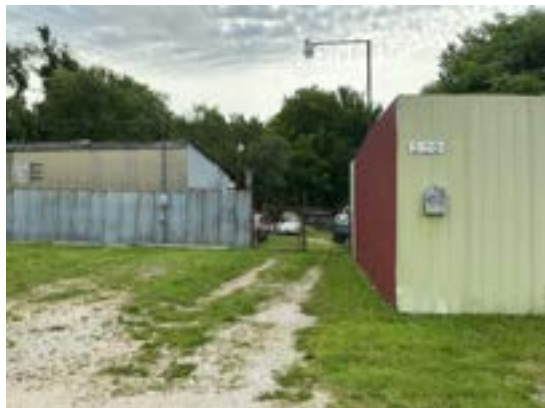
| Primary Follow-Up Category: Distress / Stabilization Candidate | | |
| Key Notes: Property scored high for Environmental Concern and Physical Distress, with elevated Redevelopment Opportunity and readiness. Observed conditions included distressed vegetation, suspected hazardous storage, exterior wall damage, collapsing elements, broken glass, open storage, loose debris/materials, encampment indicators, unsecured hazards, and abandoned vehicles. Future follow-up may include site condition review, owner coordination, environmental due diligence, and stabilization or cleanup planning. | | |

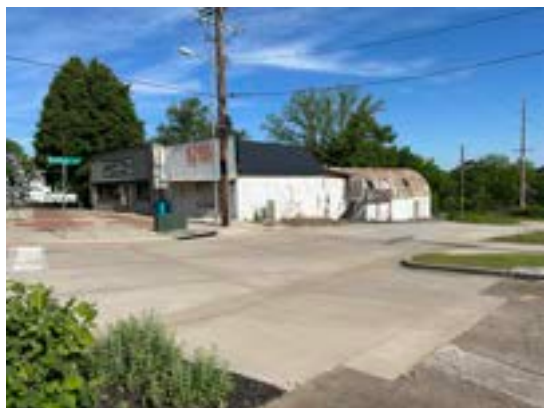
| Primary Follow-Up Category: Strategic Redevelopment / Site Condition Review | | |
| Key Notes: High-visibility corner property along College Street with strong Redevelopment Opportunity indicators, including arterial/collector frontage, corner lot location, unobstructed roadway visibility, nearby vacant and underutilized parcels, and proximity to park/open space and a commercial cluster. The site also exhibits high physical distress due to boarded openings, exterior wall damage, loose debris/materials, graffiti, and no active use observed. Environmental Concern was elevated but limited, primarily driven by distressed vegetation. Future review should focus on property condition, adaptive reuse feasibility, owner coordination, and whether the site could support reinvestment as part of the College Street/Broadway area opportunity cluster. | | |

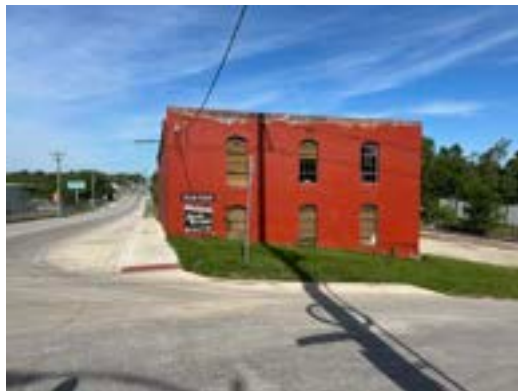
| Primary Follow-Up Category: Strategic Redevelopment / Adaptive Reuse Review | | |
| Key Notes: Historic former bottling company property with strong corridor visibility, including arterial frontage, unobstructed roadway visibility, and proximity to a major intersection. The site scored high for Physical Distress and elevated for Redevelopment Opportunity, with indicators including exterior wall damage, broken glass, loose debris/materials, vacant appearance, and no active use observed. Redevelopment potential is supported by adaptive reuse potential, visible storefront/public interface features, direct driveway and corner lot access, visible or apparent utility service, and proximity to park/open space and trail assets. Future reviews should focus on building condition, adaptive reuse feasibility, owner coordination, and whether the site could contribute to corridor reinvestment near the western College Street opportunity area. | | |

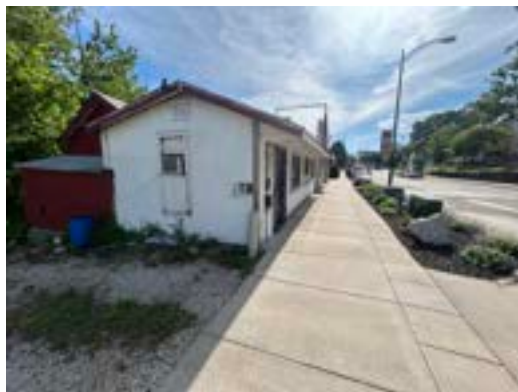
| Address | 1037 W College St | |

| <b>Key Notes:</b> High-opportunity corridor property with high Physical Distress and low Site Readiness. Indicators included boarded openings, roof deterioration, exterior wall damage, foundation cracking, structural sagging, loose debris/materials, abandoned vehicles, vacant appearance, and no active use observed. Despite readiness constraints, the property's corridor location, Redevelopment Opportunity score, and adjacent opportunity context support inclusion as a Priority Review Property. |
